Inspection Report

People, Places & Things LLC

Date: 10/7/2015	Time: 05:00 PM	Report ID: 0249
Property:	Customer:	Real Estate Professional:

Type of Dwelling:
Condominium

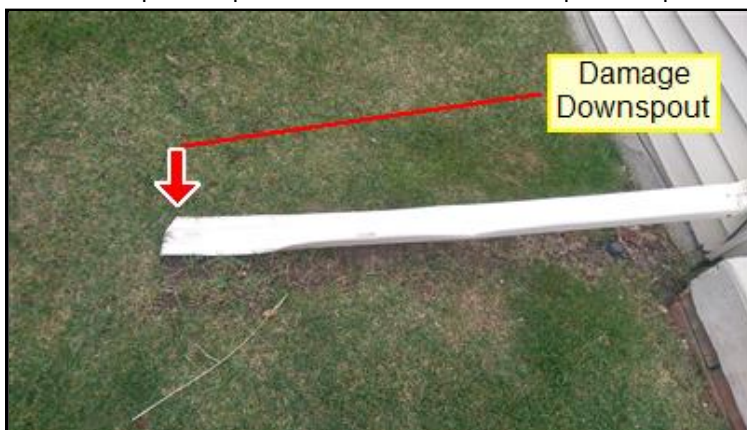
1.3 Picture 1 Downspout

1.3 The downspout damaged at the front left corner of home. Erosion can continue or become worse if not corrected possibly leading to water intrusion. A qualified person or contractor should repair or replace as needed.

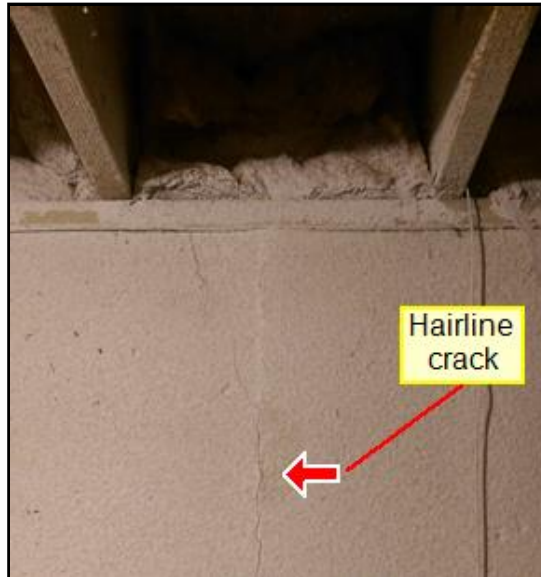
5.1 Picture 1 Wall in the utility room

5.1 (1) The Foundation wall at the Utility room has hairline crack. No repairs are needed or foreseen at this time. It is recommend that you monitor periodically.

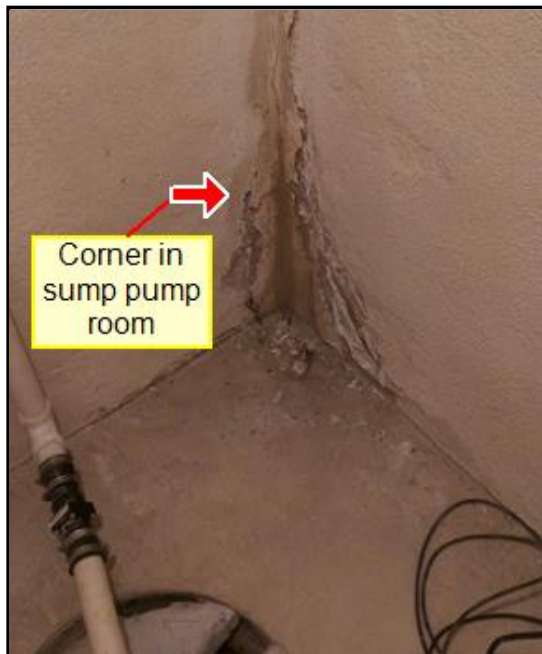
5.1 Picture 2 Sump Pump Room

(2) The foundation wall on the wall shows wet stains indicating moisture or intrusion did or still may occur at the sump pump room. Due to recent dry weather, I am unable to determine if the leak still exists. I recommend monitor and repair if the leak reappears.

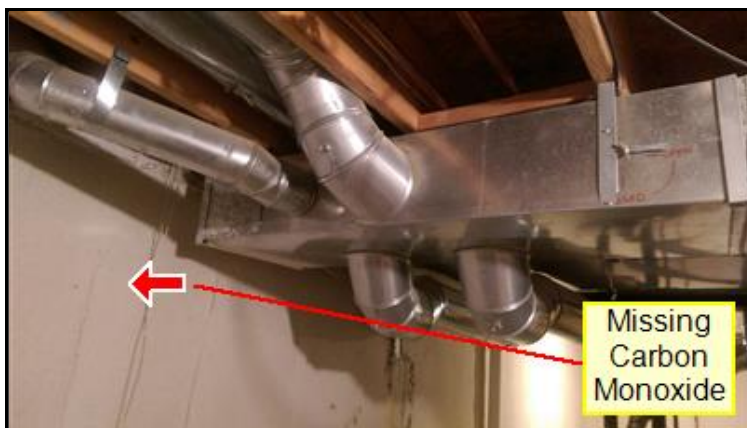
7.8 Picture 1 Basement

7.8 There is no carbon monoxide detector found in home. It is recommended that one be installed according to the manufacturer's instructions.

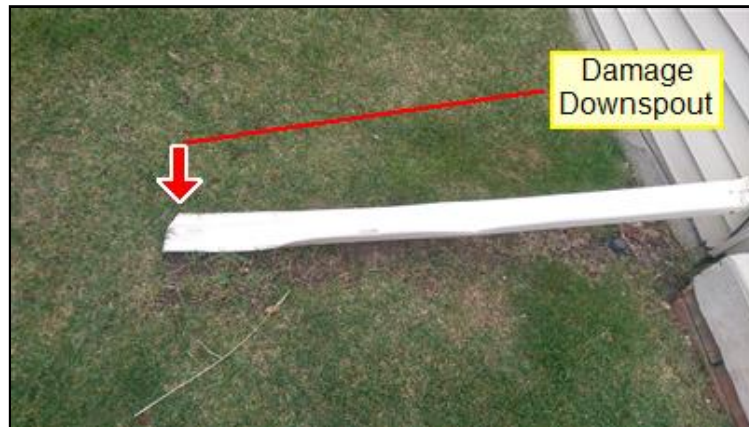
1.3 Picture 1 Downspout

The downspout damaged at the front left corner of home. Erosion can continue or become worse if not corrected possibly leading to water intrusion. A qualified person or contractor should repair or replace as needed.

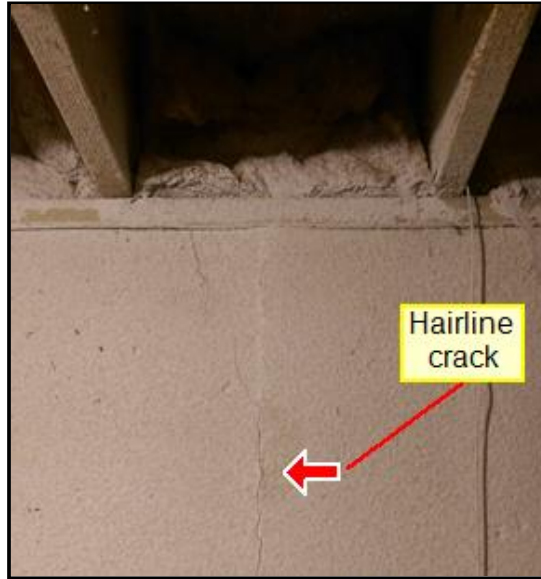
5.1 Picture 1 Wall in the utility room

(1) The Foundation wall at the Utility room has hairline crack. No repairs are needed or foreseen at this time. It is

recommend that you monitor periodically.

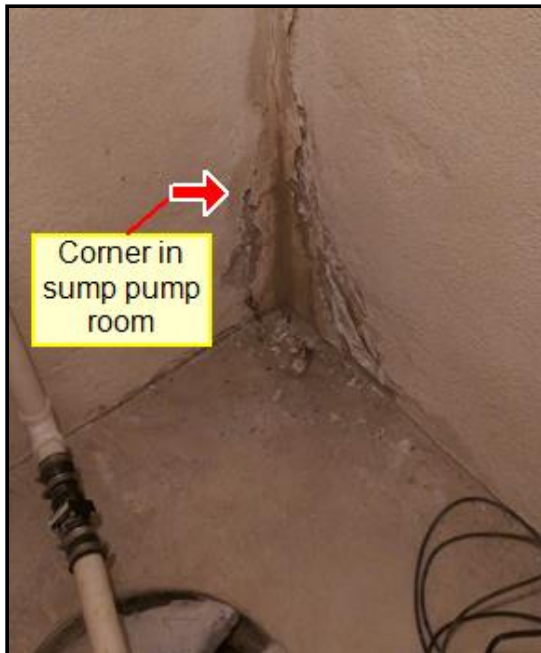
5.1 Picture 2 Sump Pump Room

(2) The foundation wall on the wall shows wet stains indicating moisture or intrusion did or still may occur at the sump pump room. Due to recent dry weather, I am unable to determine if the leak still exists. I recommend monitor and repair if the leak reappears.

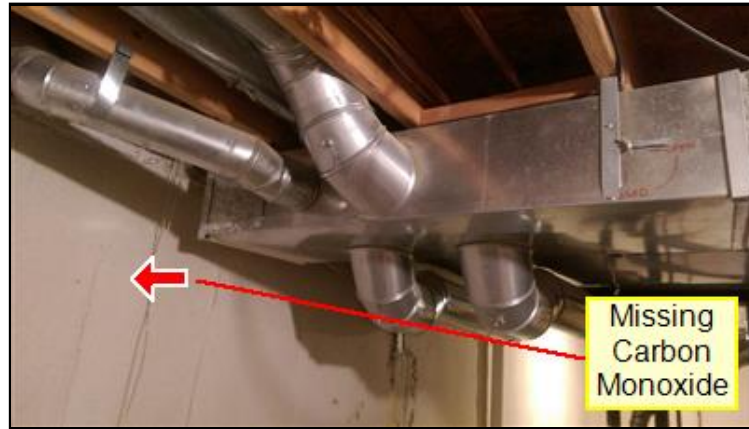
7.8 Picture 1 Basement

There is no carbon monoxide detector found in home. It is recommended that one be installed according to the manufacturer's instructions.
